Preliminary Report

**Accident involving Air India's B787-8 aircraft bearing registration VT-ANB
at Ahmedabad on 12 June 2025**

Aircraft Accident Investigation Bureau

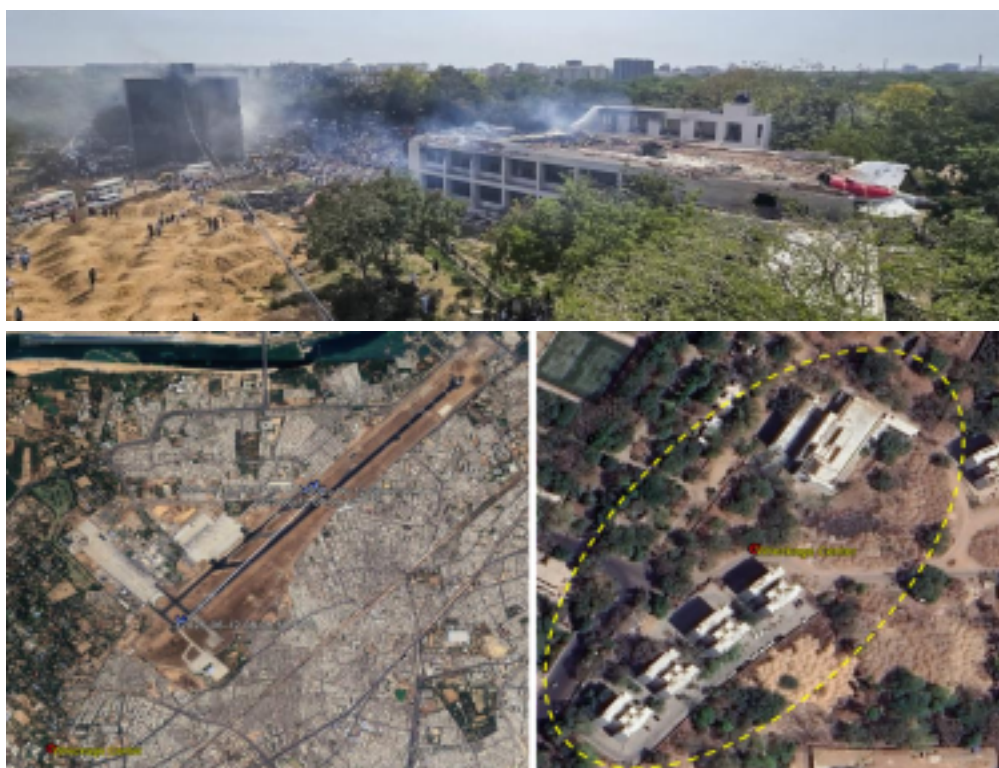
Figure 1 Accident Site with respect to airport (left) and debris field

The Aircraft was destroyed due to impact with the buildings on the ground and subsequent fire. A total of five buildings shown in the figure below were impacted and suffered major

structural and fire damages.

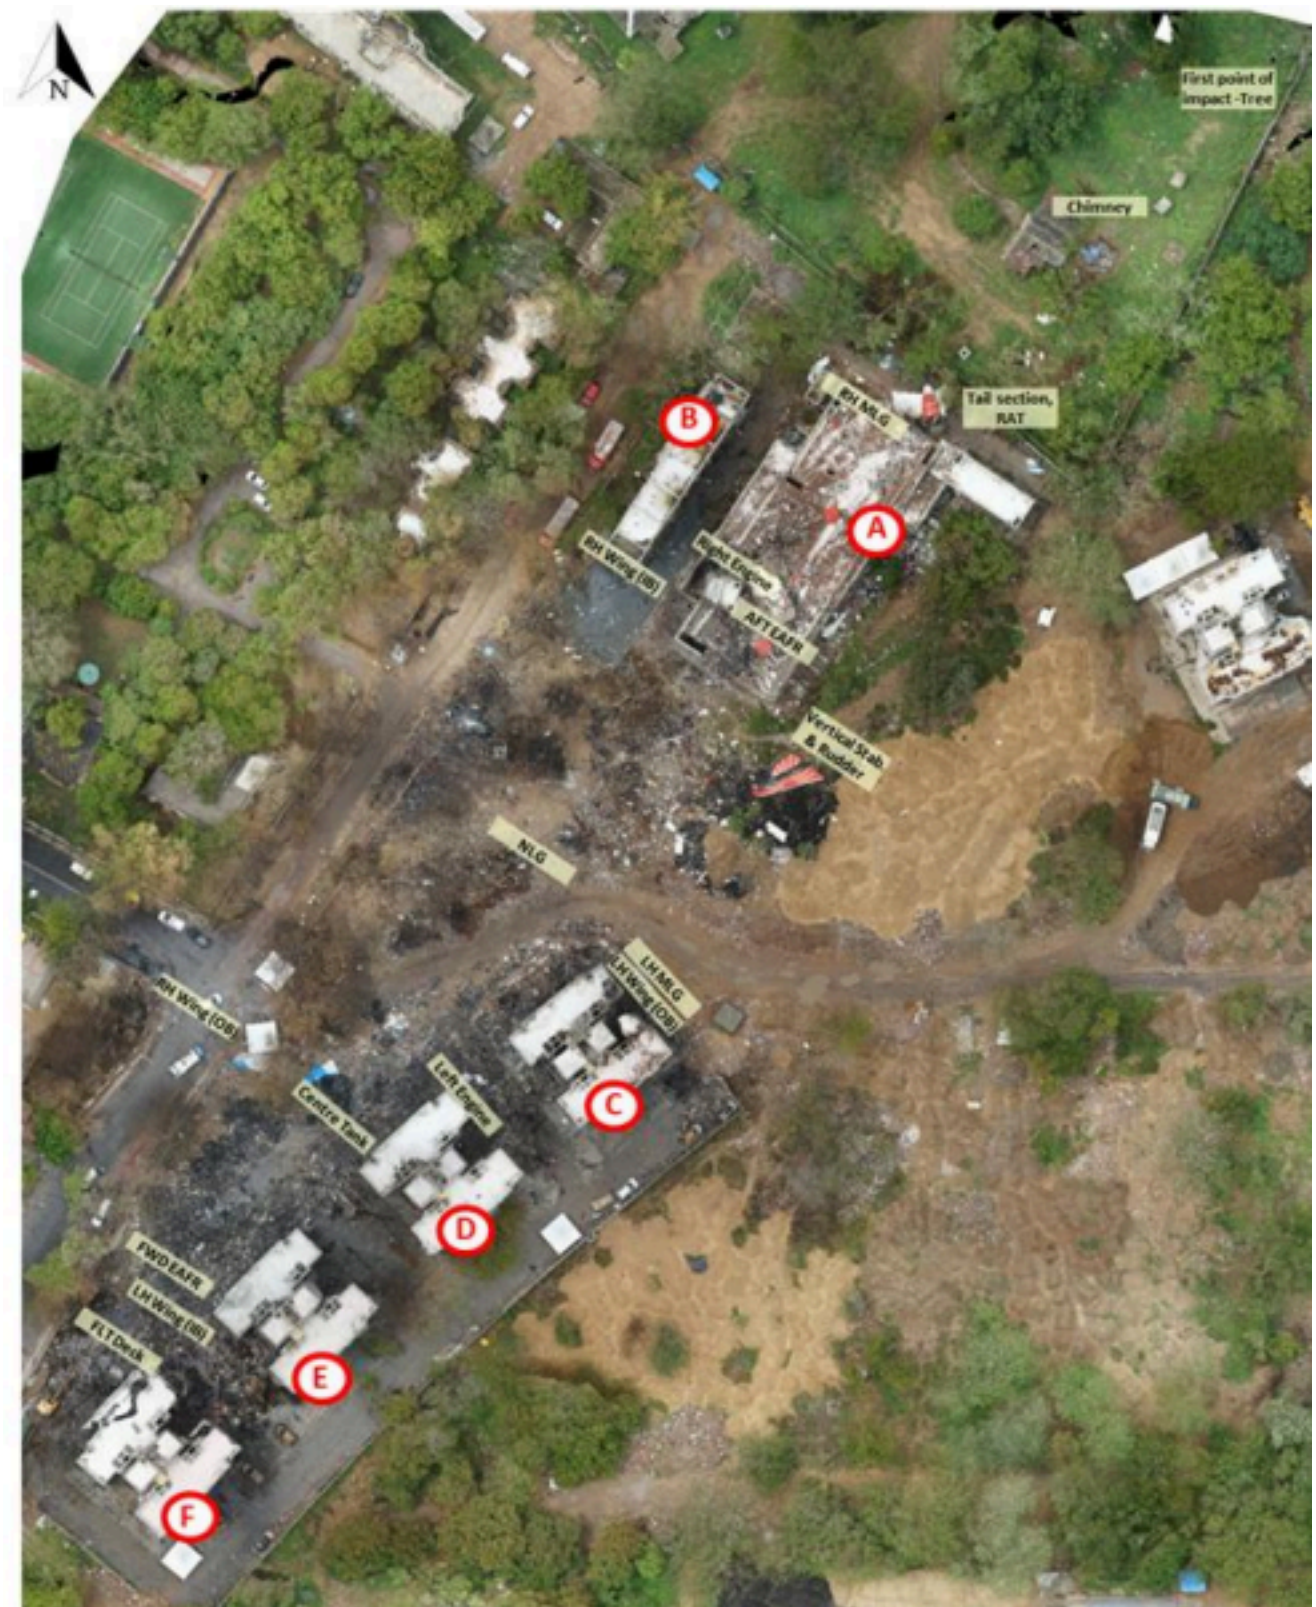
Figure 2 Wreckage layout

After takeoff, the aircraft impacted the BJ Medical College hostel which is 0.9 NM from the departure end of Runway 23. The Emergency Locator Transmitter (ELT) was not activated during this event. The wreckage, from the first impact point till the last identified aircraft item, was distributed in an area of approx. 1000 ft * 400 ft. A layout of the crash site has been given in *Fig. 2* indicating the significant parts of the aircraft. The buildings at the wreckage site have been labelled alphabetically from A-F in the layout for easy reference.

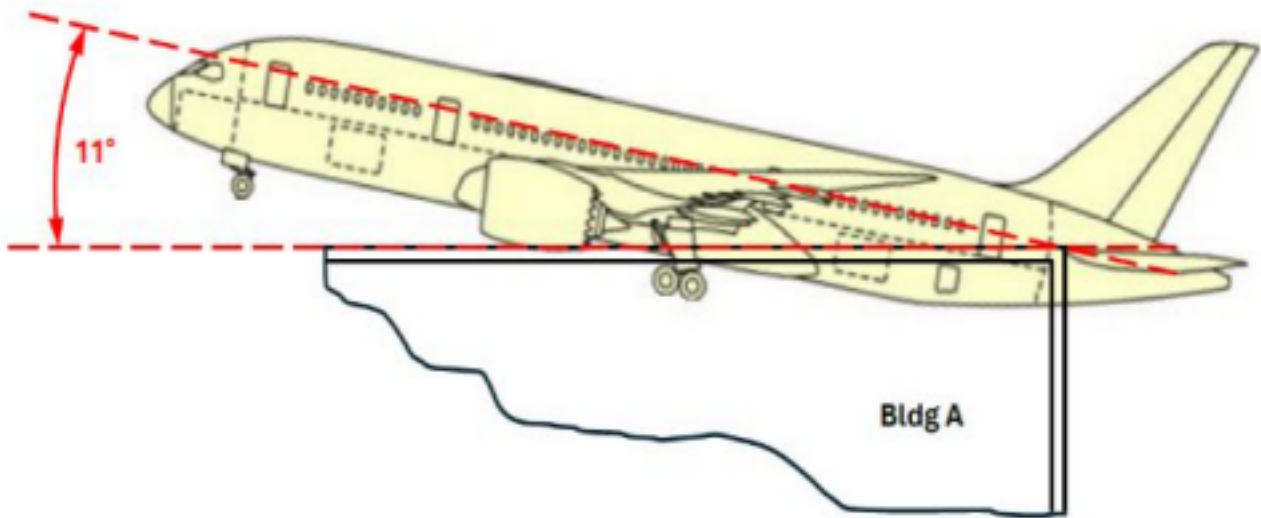
As the aircraft was losing altitude, it initially made contact with a series of trees and an incineration chimney inside the Army Medical Corps compound before impacting the northeast wall of the Building A. The distance between the tree on which the aircraft made its initial contact and the point on the Building A where the aircraft impacted is 293 ft. As the

Figure 3 Aircraft attitude at the time of impact with Building A aircraft moved forward, it continued fragmenting and collided with other structures and vegetation. The impact witness marks on the building and airplane indicated a likely nose-up attitude (about 8°) and wings level.

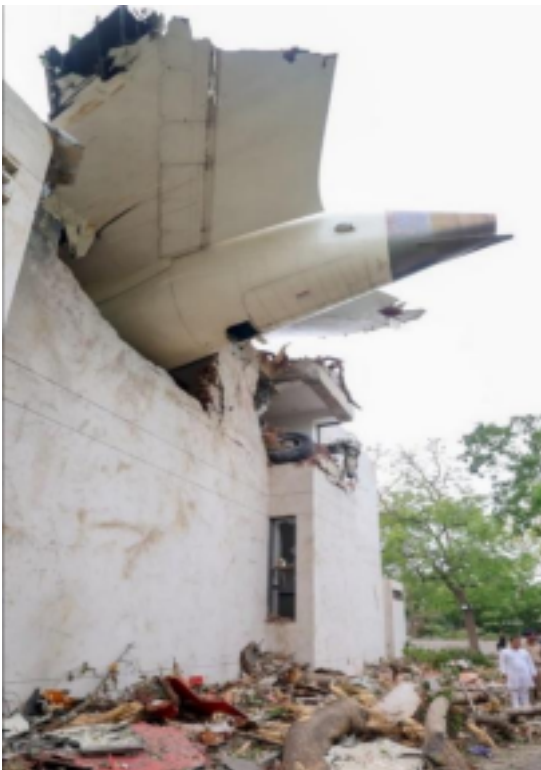
Figure 4 Tail section & RH MLG embedded in the

The vertical stabilizer (*fig. 5*) separated from the aft fuselage and came to rest about 200 feet south of the initial point of contact with the Building A. The tail section and the RH Main Landing Gear (MLG) of the aircraft were found embedded in the northeast wall of the Building A while the rest of the airplane continued its forward movement.

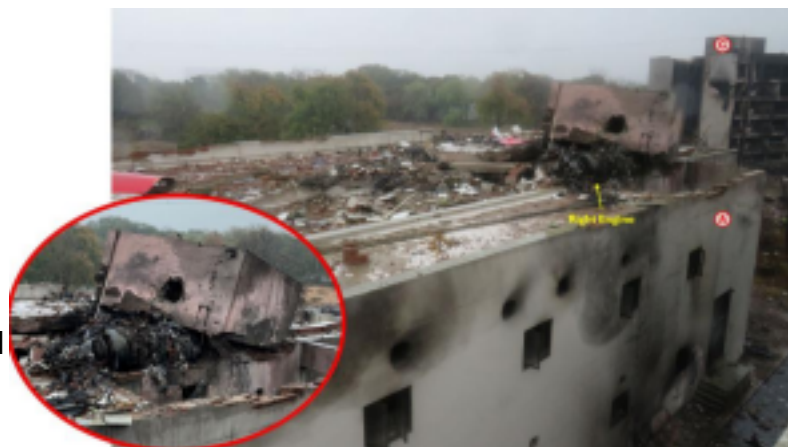
Figure 6 RH Engine

As the airplane continued its path across the roof of the Building A the right engine (*fig. 6*) struck the concrete water tank structure, separated from the airplane and rested underneath the water tank structure facing a heading of approx. 226 degrees near south west wall of the Building A.

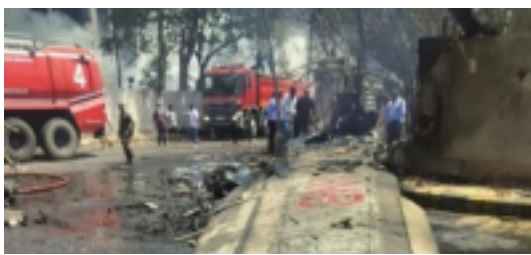
Figure 7 :

the areas surrounding the buildings. The right-wing mid-section and the outboard section (*fig. 7*) was about 280 feet and 520 feet southwest respectively from the initial point of contact with the Building A.
